Kerani Heights Estate Stage 1

GITA Inspection Verification Report

Prepared For:	Ginsan Constructions	
Report Number	Report Number D20369A V2	
Version Release Date	19 August 2020	
Report Released By	Janaka Somaratne	
Title	Lab Manager

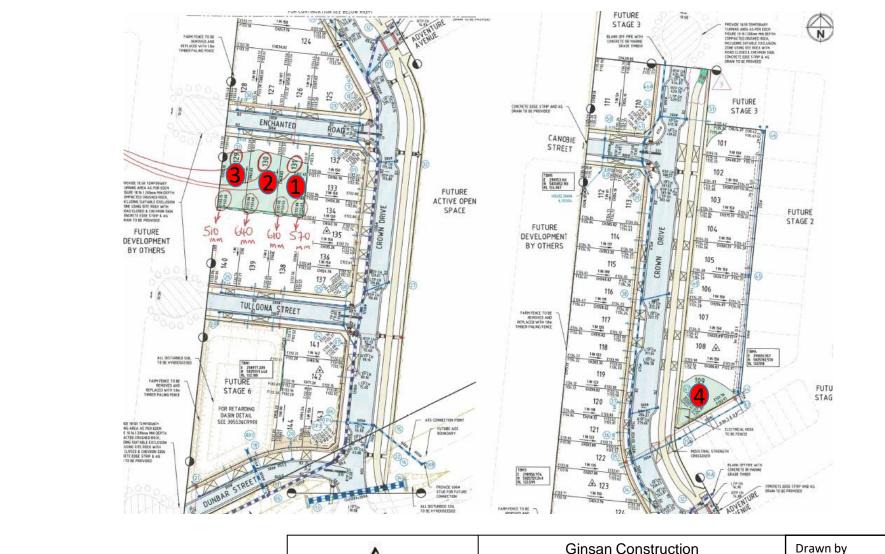
FIGURE 1

plan (D20369D1, Appendix 1) providing a schematic of test locations across the extent of scope of works for every placed layer of fill is also documented.

Test Location
