Kerani Heights Estate Stage 6

GITA Inspection Verification Report

Report Number	D20406A V1
----------------------	------------

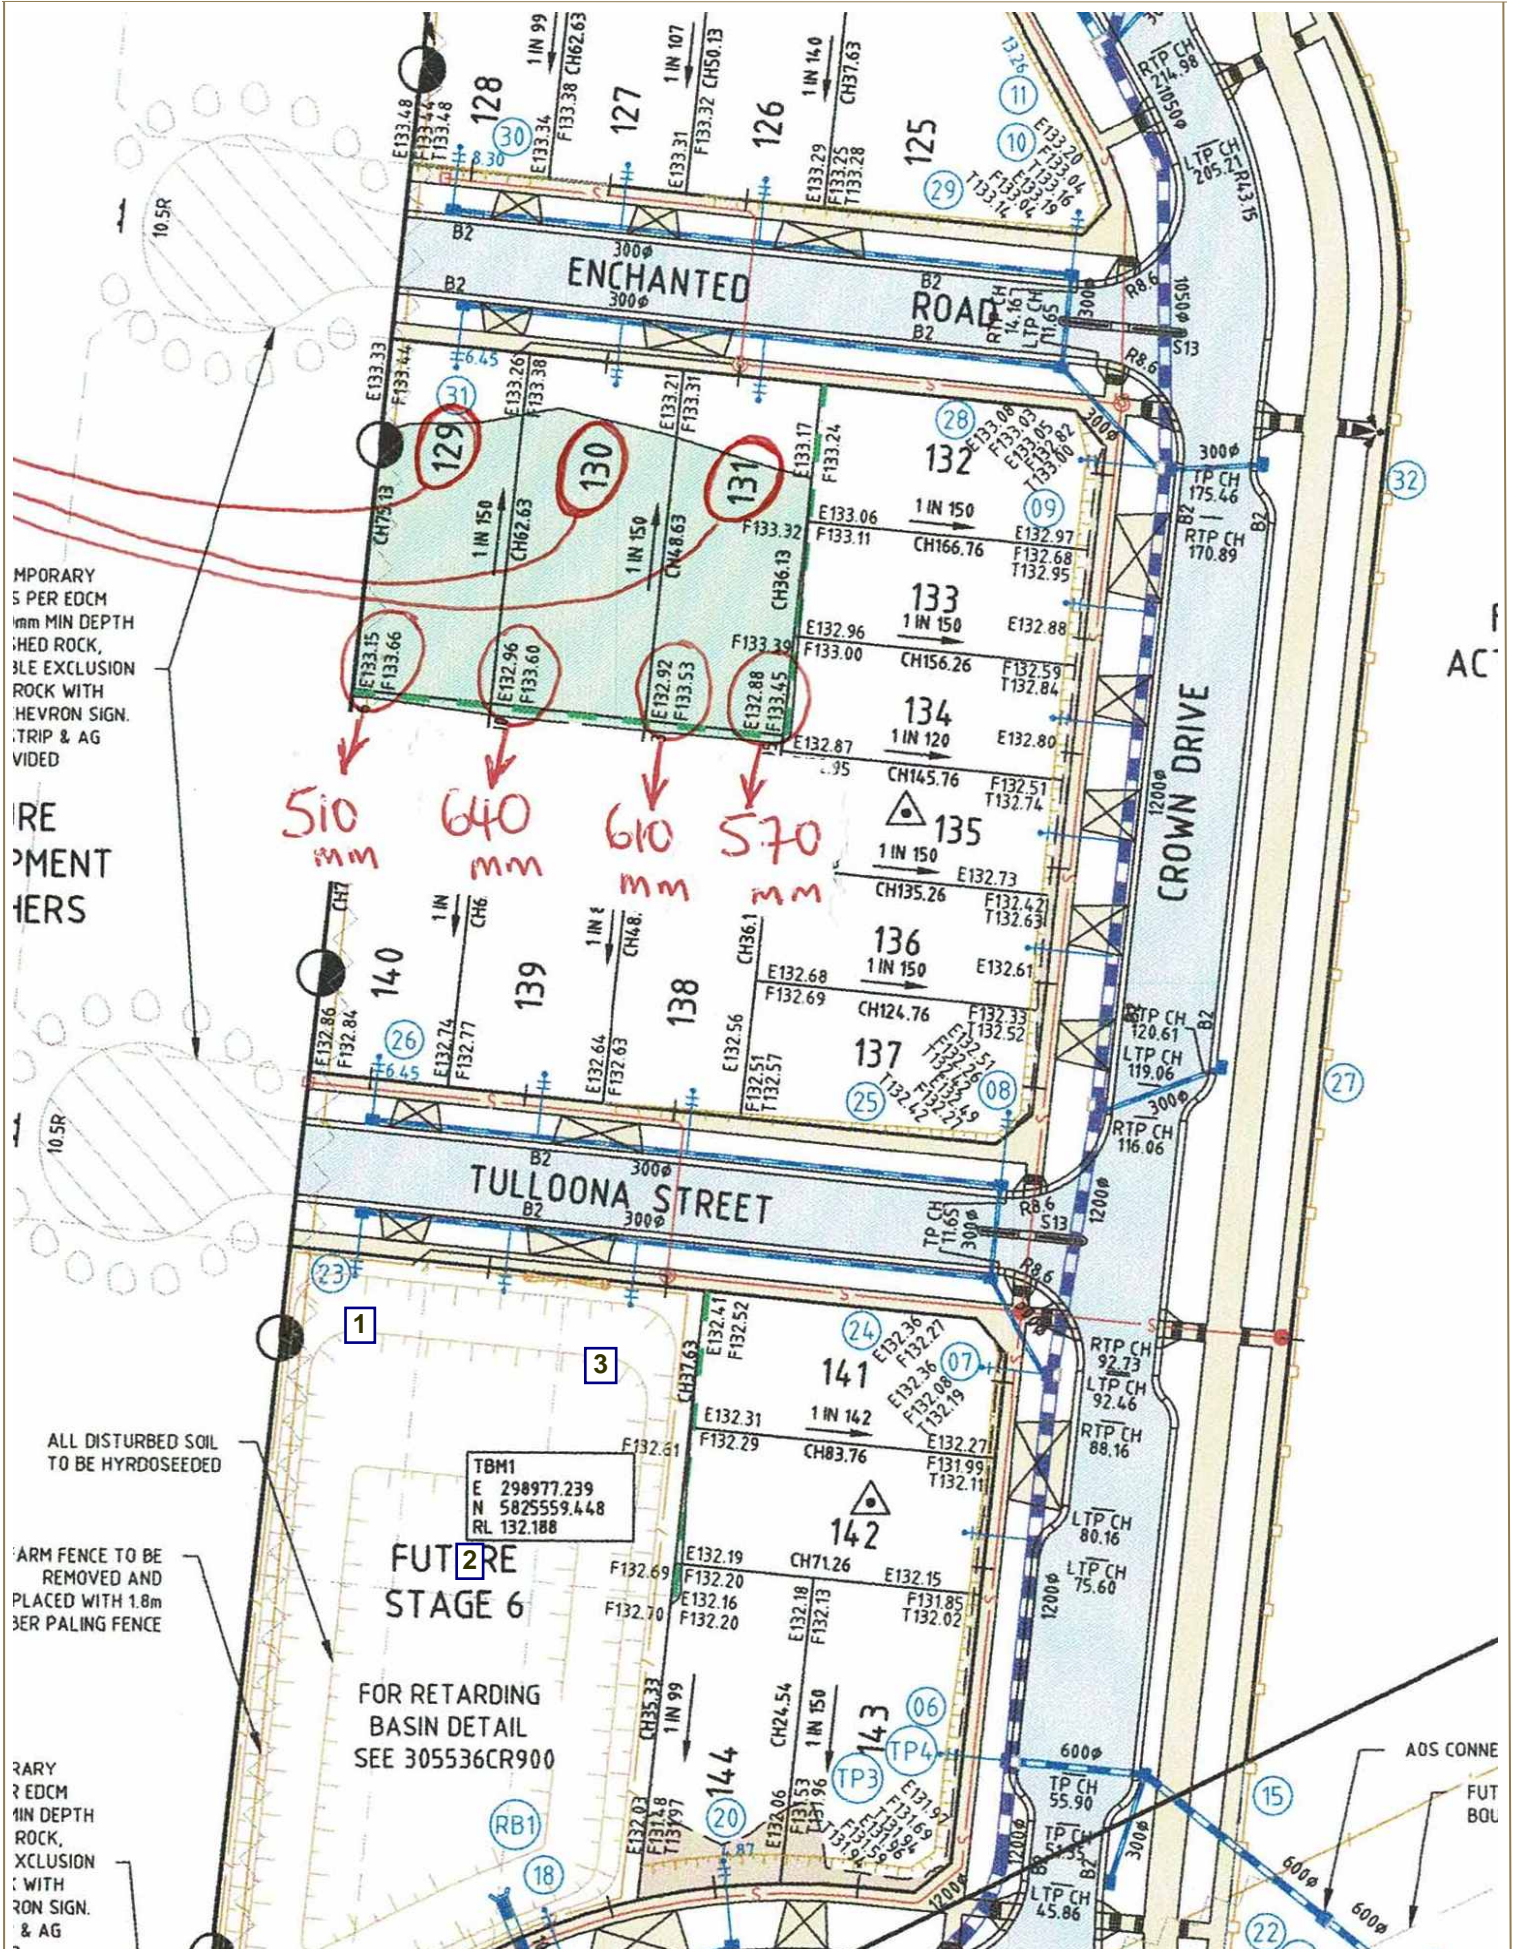
Appendix 1: Test Location Plan

The area on which fill was placed is shown on site plan (Appendix 1: *Test Location Plan*) based on drawings prepared by Spiire (Drawing Reference: 305536CR200) and provided by Ginsan Construction Pty Ltd.

Compaction Verification testing is summarized in a detailed test register with test certificates attached provided in Appendix 2: *Compaction Test Register and Test Certificates*. A test location

plan (D20406D1, Appendix 1) providing a schematic of test locations across the extent of scope of works for every placed layer of fill is also documented.
